Learning from the Longships

Part 2: The Ties That Bind

Furniture maker David Jones continues his saga of a backyard boatbuilding project inspired by Viking vessels.

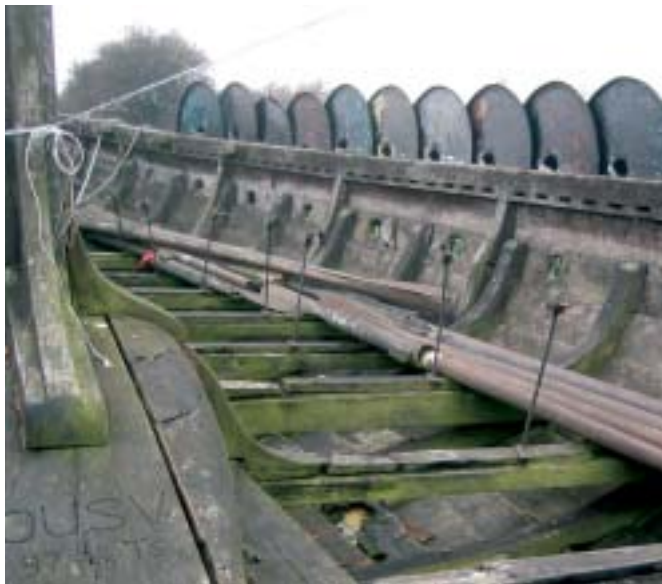
The Danish replica longship Hugin at Broadstairs in Kent was built in 1949 at Frederikssund, Copenhagen.

On the day, a large ladder was provided and I clambered aboard. As there is too much to take in and you never know what might turn out to be important at some later stage, I photographed everything in sight. Everything was there: sails, oars, spars. But sadly all the components were in a very bad state of repair. I don't know whether to envy or commiserate with those who get the job of restoration as its removal will be almost as hard as getting the Gokstad ship out of the blue clay!

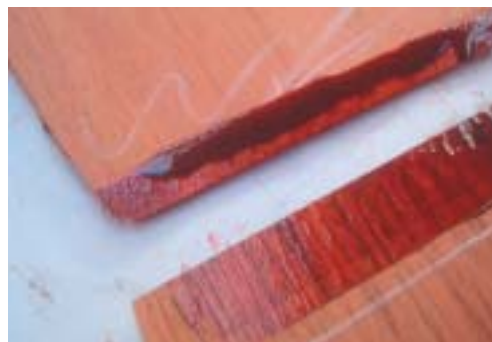
A trial assembly after coating just one of the joint faces with glue confirms good contact.

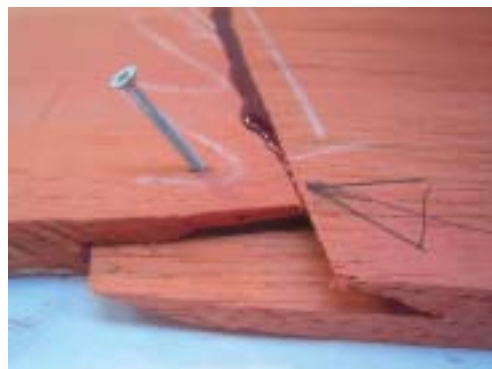
Slim crosshead screws, available from most builders' merchants, locate the joint and...

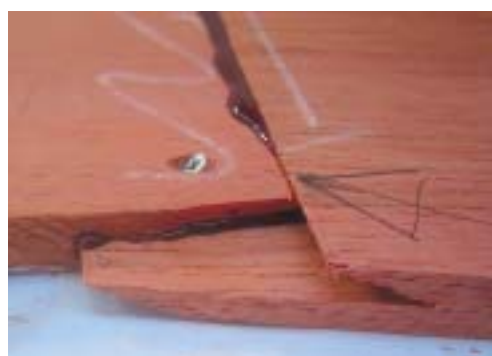
... then driven in at an angle, their smooth shanks help pull the joints together properly.

When the previous plank has been prepared by planing away any edge defects to give a smooth sweep from stem to stern and the lands have been slightly tapered – but only at the very ends, as I believe these lands help to drive air underneath the hull – the next plank has a gauged groove routed out to take a bead of Sika compound. Compounds which have to stretch require some main body or volume to provide the flexibility – tight smear joints just tear.

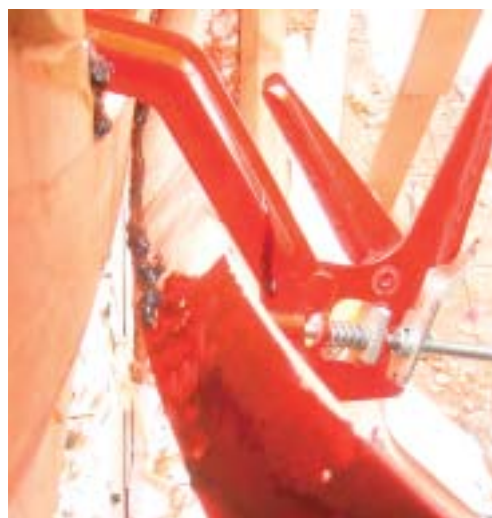
Looking down on the joint with the Sika marine mastic at the top of the picture and the RS12 resorcinol adhesive lower down.

When the correct position is obtained, gluing can commence. I used resorcinol marine adhesive for the end of the plank where it meets the stem, holding it in place with traditional speed cramps. Then as the plank progresses, the gauged out hollow of the plank being offered is filled with the Sika compound which eventually dries on the surface but remains virtually in a thixotropic state where not exposed to the air. This is not a glue as such but a very flexible caulking compound with Sika’s impressive water resistant properties. The plank is secured using fine 1¼” (32mm) screws with smooth shanks which allow the outer plank to be pulled down firmly on to the previous one. They are of such a size that they require no pre-drilling in cedar and provide a perfect preliminary tight fitting hole for subsequent riveting. This combination of easily removable clamps, gun applied compound and self-driving screws means that I can glue and secure a 22’ (6.9m) plank in just one hour. The riveting, using copper roves and nails, takes somewhat longer!

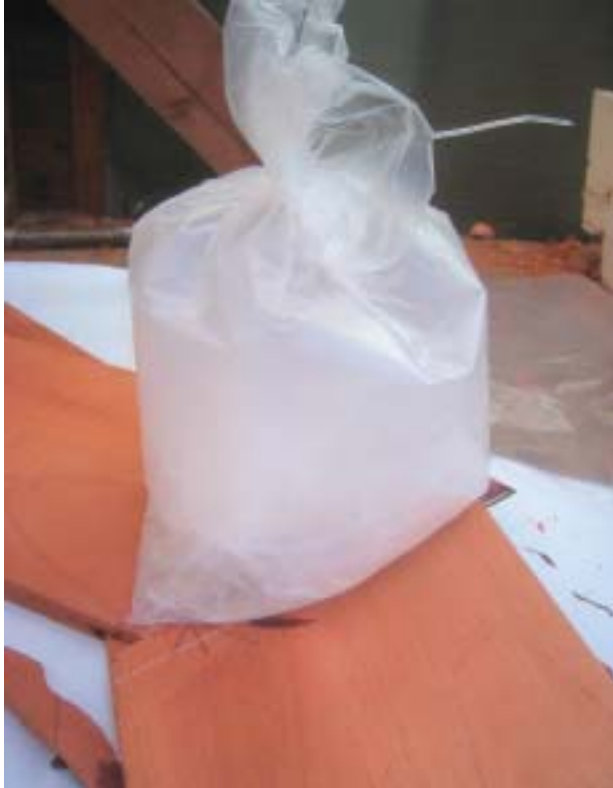
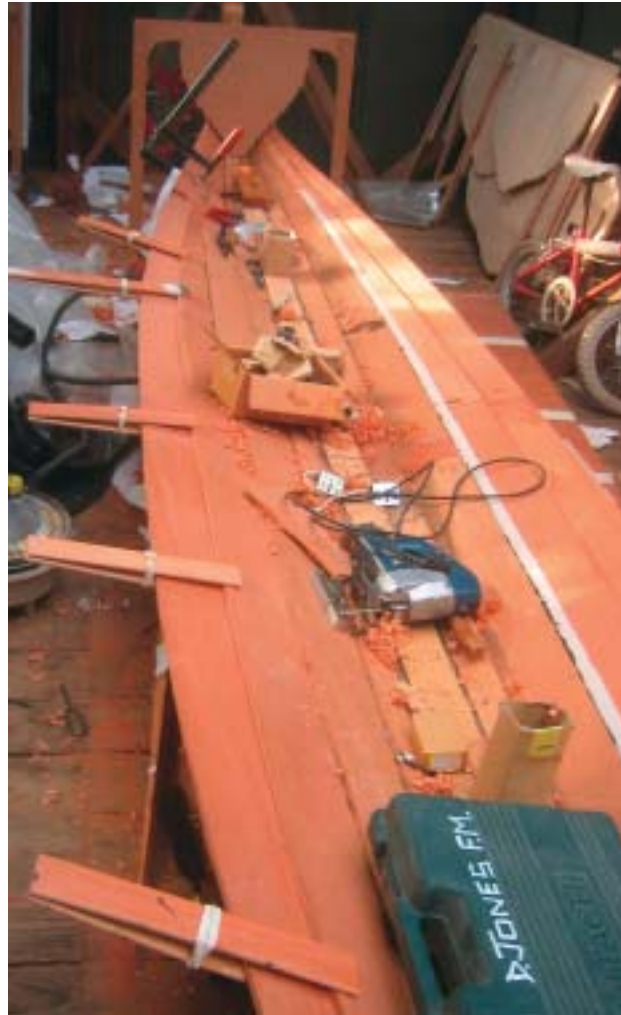
*Above: To maintain an adequate curing temperature, the resorcinol glued joint gets its own hot water bottle.
Right: Home-made clamps fabricated from bedding slats have enough reach to hold the plank lands together.*

I considered slit ‘collars’ of plastic pipe but could not find pipe large enough in diameter to give sufficient reach. So I used curved laminate bed slats, cut them to the required length, hinged them by driving a screw in at one end and then I applied the strongest rubber bands I could buy – sold by camping shops to hold guy ropes to tent pegs. These clamps have quite a strong grip but the pressure is easily adjusted and when over-stressed by an incorrectly placed plank, they give first.

store the resorcinol adhesive in the house as storage below 10°C can cause permanent damage to many glues – for example, PVA adhesive becomes lumpy – but even with the adhesives stored in the warm, as winter came on gluing would inevitably become more of a problem. So the challenge was to maintain a degree of warmth in a number of locations at the same time in an unheated shed. My solution was to pour boiling water into a freezer bag and secure with an electrical plastic tie. Then, as this would cool far too quickly, I placed it in another bag, semi-secured the tie, then inflated it like a balloon, twisting the bag and using a second tie to make it fully secure. As the water sits at the bottom, a large proportion of the water's heat sits on the flat plank joint while the inflated bag provides insulation at the sides and the top.
